**Flood Control Project Maintenance  
Levee Inspections**

**2019 Channel Summary Report**

**Placer County**

**Truckee River**

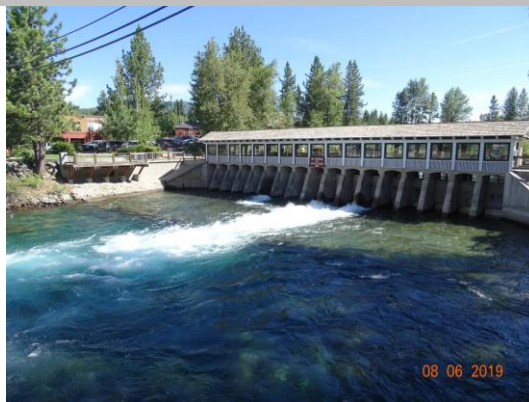
Photo 1 of 1 : CH\_2019\_NA0045\_13\_11\_20190806\_00027.jpg

Rating **	A	Issue No.	11	GPS Lat/Long
Issue Type +	Ma	Location *		39.166845 °
Category	Rivers, Channels & Designated Flood			-120.144424 °
Item	Vegetation & Obstructions			
DWR ID	DWR_NA0045_13_c_2012_11			
Action/Comments				
Inspector Comments: Minimal, scattered obstructions or vegetation. The flow is not impeded.

View of the river from Highway 89, looking upstream towards the outlet structure. Summer 2019.

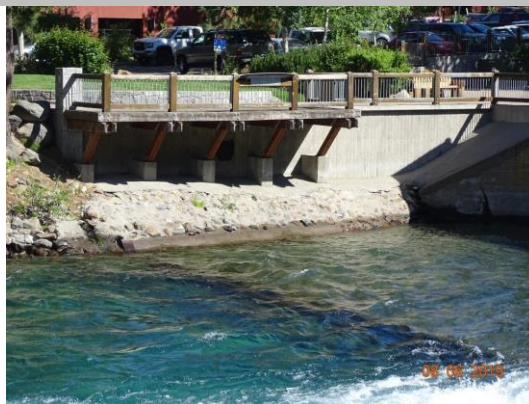
Photo 1 of 2 : CH\_2019\_NA0045\_13\_14\_20190806\_00029.jpg

Rating **	A	Issue No.	14	GPS Lat/Long
Issue Type +	Ma	Location *		39.166845 °
Category	Rivers, Channels & Designated Flood			-120.144424 °
Item	Revetments			
DWR ID	DWR_NA0045_13_c_2012_14			
Action/Comments				
Inspector Comments: Monitor scouring of revetment on the slope of the left bank.

View of the riprap on the right bank. Summer 2019.

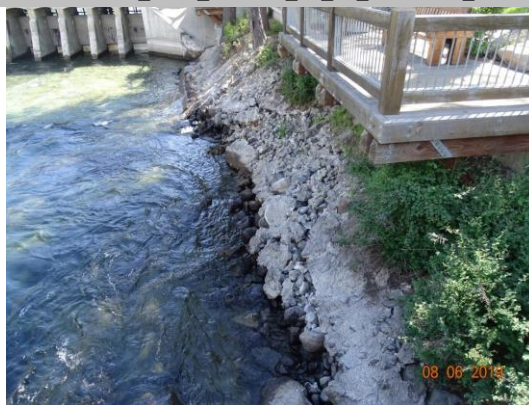
Photo 2 of 2 : CH\_2019\_NA0045\_13\_14\_20190806\_00028.jpg

View of the riprap and minor scouring on the left bank. Summer 2019.

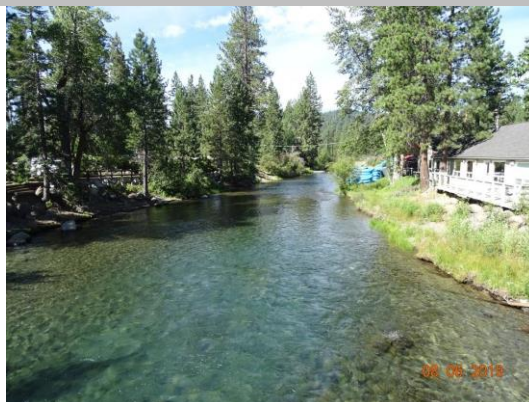
Photo 1 of 1 : CH\_2019\_NA0045\_13\_16\_20190806\_00030.jpg

Rating **	A	Issue No.	16	GPS Lat/Long
Issue Type +	Ma	Location *		39.166845 °
Category	Rivers, Channels & Designated Flood			-120.144424 °
Item	Vegetation & Obstructions			
DWR ID	DWR_NA0045_13_c_2012_16			
Action/Comments				
Inspector Comments: Minimal, scattered obstructions or vegetation. The flow is not impeded.

Looking downstream on the Truckee River from Highway 89. Summer 2019.

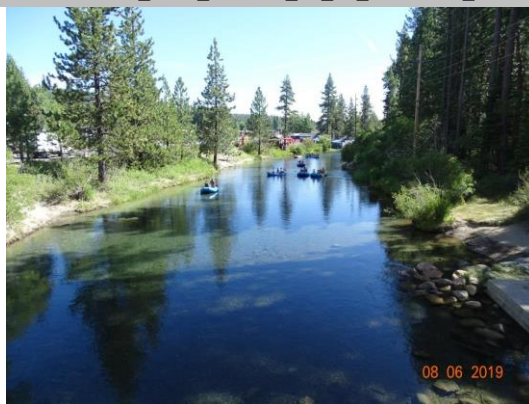
Photo 1 of 1 : CH\_2019\_NA0045\_13\_21\_20190806\_00031.jpg

Rating **	A	Issue No.	21	GPS Lat/Long
Issue Type +	Ma	Location *		39.165170 °
Category	Rivers, Channels & Designated Flood			-120.147590 °
Item	Vegetation & Obstructions			
DWR ID	DWR_NA0045_13_c_2012_21			
Action/Comments				
Inspector Comments: Minimal, scattered obstructions or vegetation. The flow is not impeded.

View of the Truckee River, looking upstream from the bike bridge.  
Summer 2019.

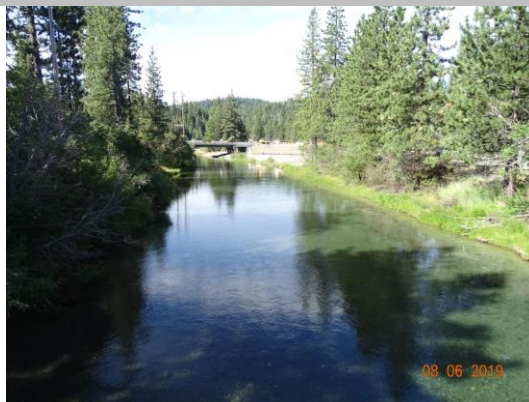
Photo 1 of 1 : CH\_2019\_NA0045\_13\_26\_20190807\_00032.jpg

Inspector Comments: Minimal, scattered obstructions or vegetation. The flow is not impeded.

View of the Truckee River, looking downstream from the bike bridge.  
Summer 2019.

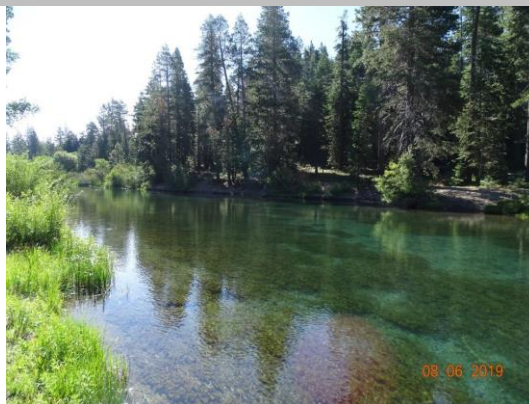
Photo 1 of 1 : CH\_2019\_NA0045\_13\_31\_20190807\_00033.jpg

Rating **	A	Issue No.	31	GPS Lat/Long
Issue Type +	Ma	Location *		39.162480 °
Category	Rivers, Channels & Designated Flood			-120.151900 °
Item	Vegetation & Obstructions			
DWR ID	DWR_NA0045_13_c_2012_31			
Action/Comments				
Inspector Comments: Minimal, scattered obstructions or vegetation. The flow is not impeded.

View of the Truckee River, looking upstream from the Tahoe City Lumber Yard. Summer 2019.

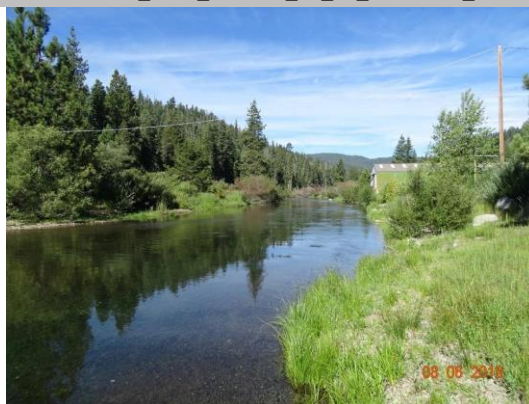
Photo 1 of 1 : CH\_2019\_NA0045\_13\_36\_20190807\_00034.jpg

Inspector Comments: Minimal, scattered obstructions or vegetation. The flow is not impeded.

View of the Truckee River, looking downstream from the Tahoe City Lumber Yard. Summer 2019.
